THE Graft

Natural Bone Substitute
Cancellous Granules

THE Graft 3rd Clinical Case Report
Exceptional Technology Proven with Distinct Results

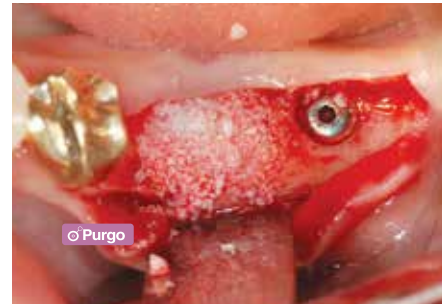
3 Grafting the bone substitute, THE Graft for the peri-implant bone defects of #36

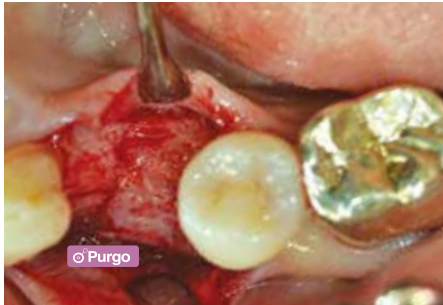
9 Increased bone width is observed after removal of titanium mesh

“It was a case of a 64 year–old female with buccal bone loss due to the chronic periodontitis. A GBR was performed and THE Graft, titanium mesh and resorbable membrane were applied for space maintenance. Clinical test as well as biopsy showed the good results and even the cortical bone line was visible from radiological data.”

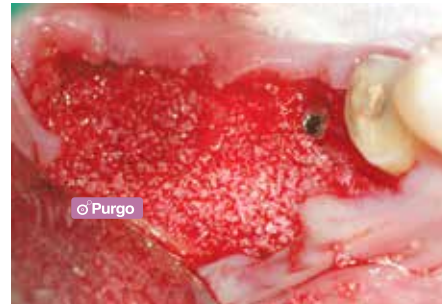
2 Horizontal bone resorption is observed after placing implant for #46, Grafting the bone substitute material, THE Graft (13,8,26)

“It is a case where the extracted tooth needed to be preserved and alveolar bone was horizontally absorbed.
THE Graft is observed to have an outstanding result with horizontal augmentation to support implant and balance with the surrounding bone.”

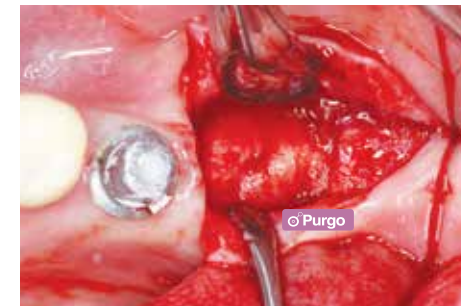
8 2nd surgery re-entry for #37, newly formed tissue is observed on the upper part of implant

“It was a case with a severe bone defect. After the extraction, treatment was conducted for healing of gingiva with socket preservation and GBR was conducted as the 1st surgery. After 4 months, samples were taken for biopsy and the 2nd surgery was conducted.”

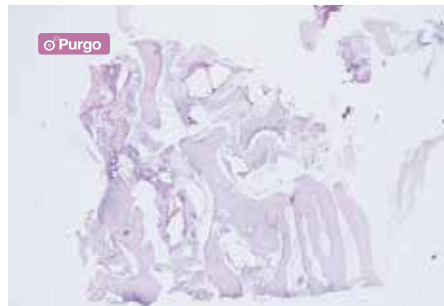
Decalcified section showed trabecular osteophytes which were partly anastomosed. This graft lesion was competent with favorable bony remodeling.
