THE Graft 4th Clinical Cases Report

Natural Bone Substitute
Cancellous Granules

Randomized clinical trial of maxillary sinus grafting using deproteinized porcine and bovine bone mineral

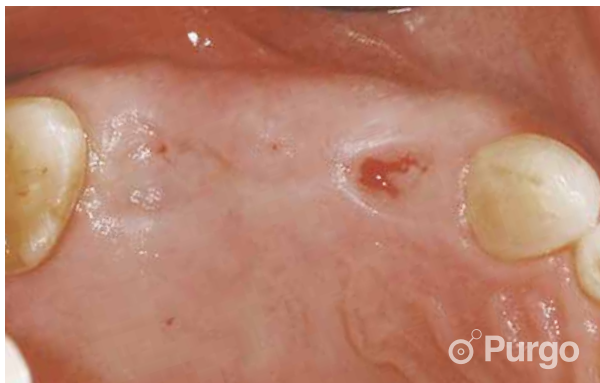
1 Pre-op clinical photograph (15.8.20)

It is a case of a 72-year-old female with large bone defect at #16 palatal side. GBR was performed 3.5 months after the extraction. As the patient was an old-aged female, a slow process of bone tissue recovery was expected. When the second surgery was performed 4.5 months after GBR, BioCover was still functioning as a barrier, and osteoid tissue which covered the implant was observed.

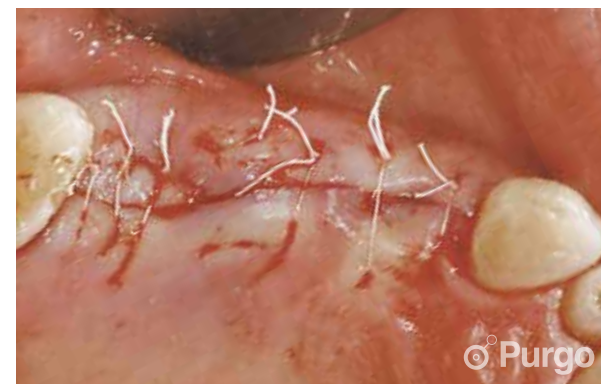
6 PTFE suture, Biotex

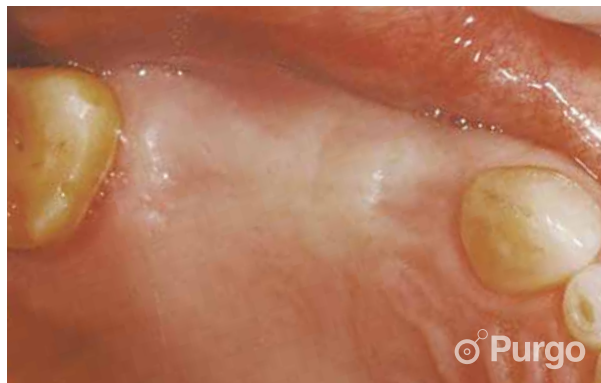
7 Healing process before second surgery (16.1.4)

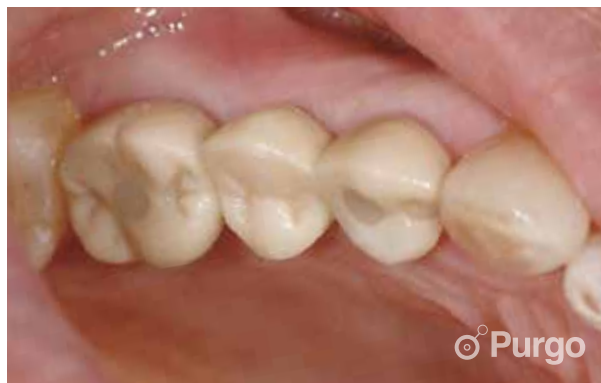
10 Loading prosthesis (16.2.26)

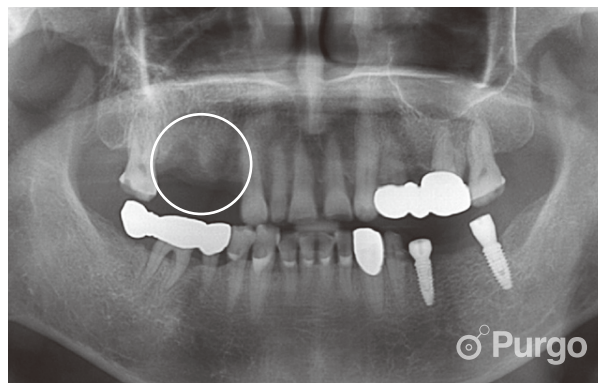
11 Pre-op panorama (16.8.20)

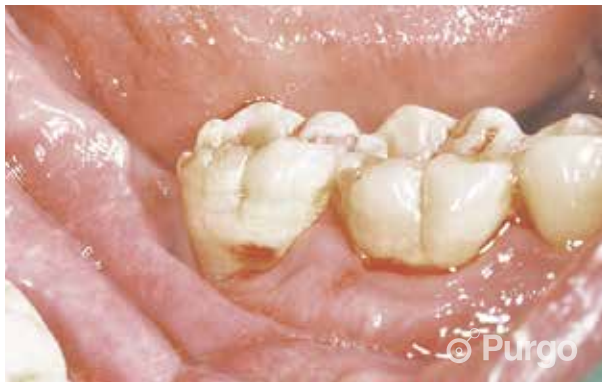
1 Pre-op clinical photograph (14.11.14)

It is a case of a patient who suffered from a severe toothache due to odontoclasia. An extraction was proceeded on the first day the patient visited the clinic, and severe defect in alveolar bone was examined right after extraction. As hardening around lesion was observed from the radiograph, the implant was planned to be placed after 7 months of a sufficient healing process, but the defect was still detected even then, and alveolar bone grafting was performed using THE Graft and BioCover on the upper part of the fixture in order to secure enough bone width. At the second surgery after 4 months, a sufficient amount of newly formed tissue was visible. The case is still under observation after 1 year of loading prosthesis and a successful, stable peri-implant mucosa and marginal bone are still observed clinically as well as radiologically.

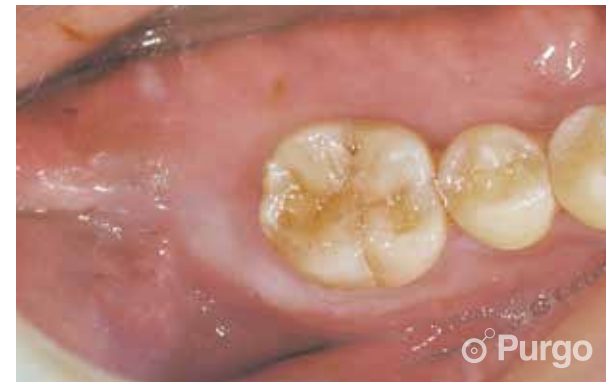
3 Healing process 4 months after the extraction (15.3.12)

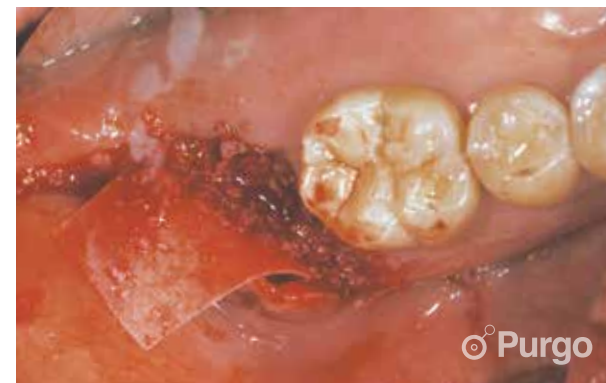
6 Grafting the bone substitute, THE Graft, after applying the resorbable membrane, BioCover

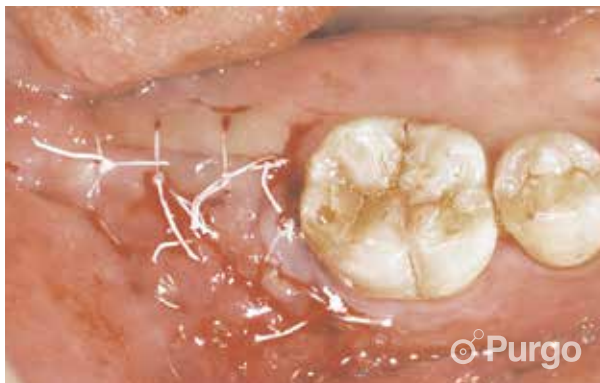
7 PTFE suture, Biotex

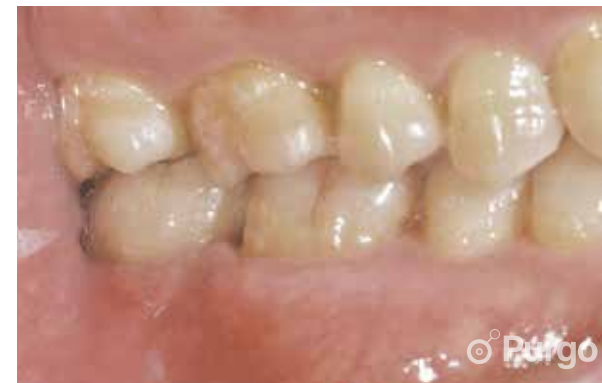
9 Buccal view after loading prosthesis (16.4.7)

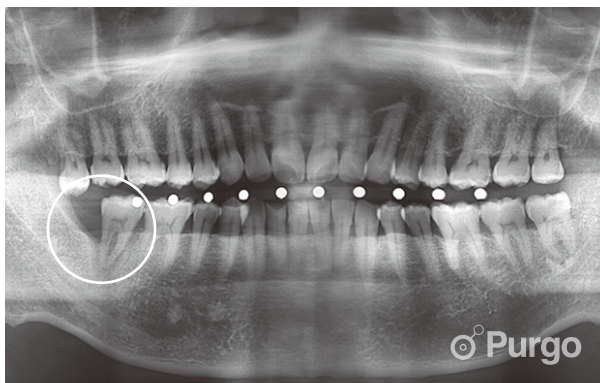
10 Pre-op panorama (14.11.14)

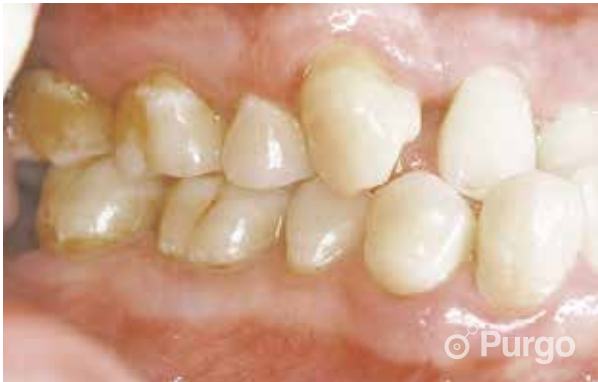
1 Pre-op clinical photograph (15.11.29)

It was a case of class III malocclusion patient with periodontitis in the molar area. Although the patient has been taking periodontal care for 10 years, molars were extracted due to the root lesion and occlusal trauma within the recent 2~3 years. The patients who kept their teeth along with periodontal treatment and occlusal adjustment for a long period of time tend to have severe bone defects when extractions happen. When flap was reflected after 4 months, a large bone defect was observed on the extraction site, so implant was fixed carefully and GBR was performed with THE Graft and BioCover. At the 2nd surgery after 6 months, a sufficient amount of new bone formation was visible and the bone quality was relatively firm.

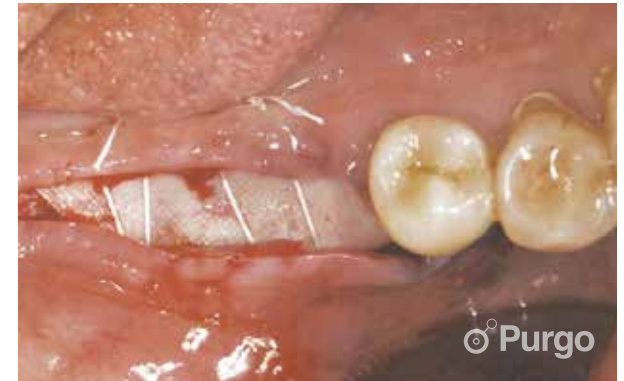
6 Applying the resorbable membrane, BioCover

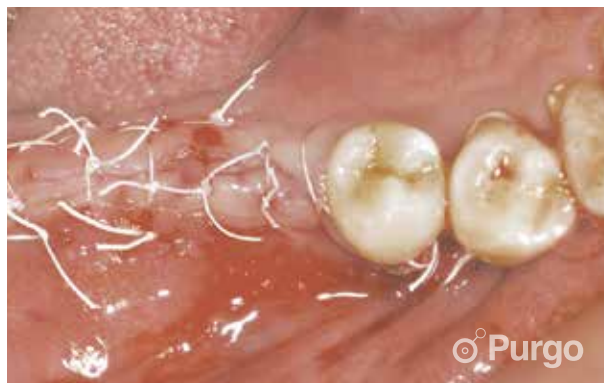
7 PTFE suture, Biotex

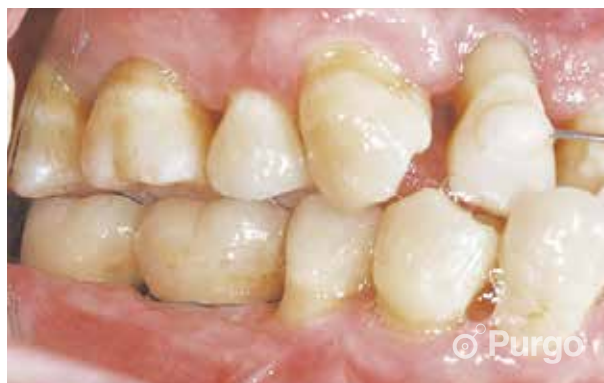
10 Buccal view after loading prosthesis (16.2.27)

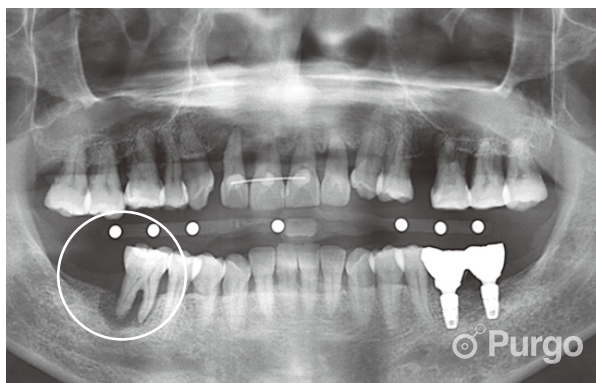
11 Pre-op panorama (14.12.3)

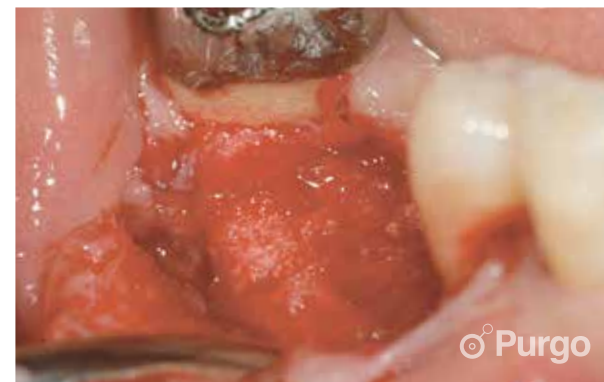
6 After removing titanium mesh

It is a case of a patient with a fractured root of #46. As there was a severe vertical bone defect, GBR was performed with a titanium mesh and the xenograft, THE Graft. 2.5 months after the bone graft, titanium mesh was exposed and removed. Implant was placed after 4 months. It has been 1 year and 5 months since the implant was placed, and vertical bone is newly formed at #46 and well kept with with increased volume of 3mm on mesial side and 5mm on distal side. This case verifies that a certain amount of vertical augmentation is possible with a xenograft alone.

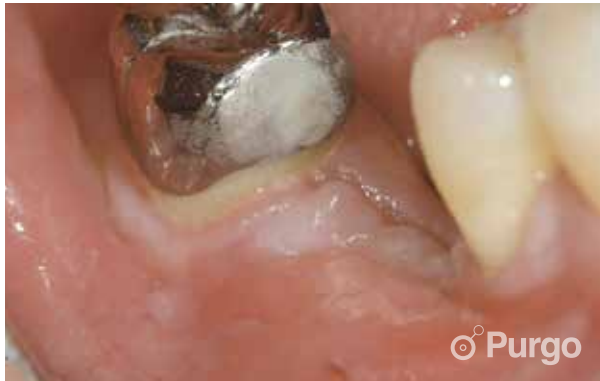
7 Healing process before implant placement (14,10,7)

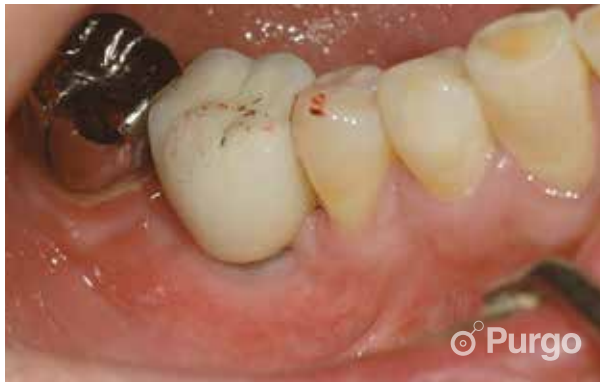
10 Loading prosthesis (15,2,25)

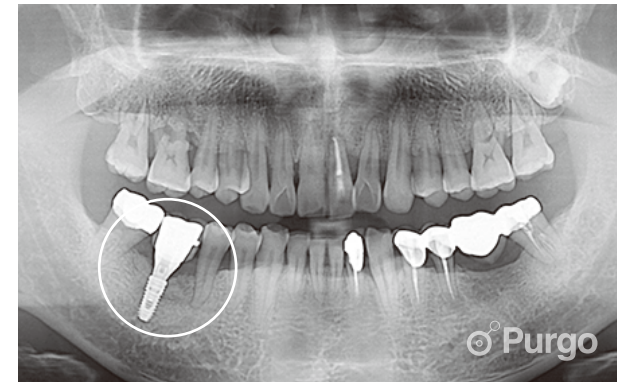
12 Panorama taken 15 months after loading prosthesis (16,6,3)

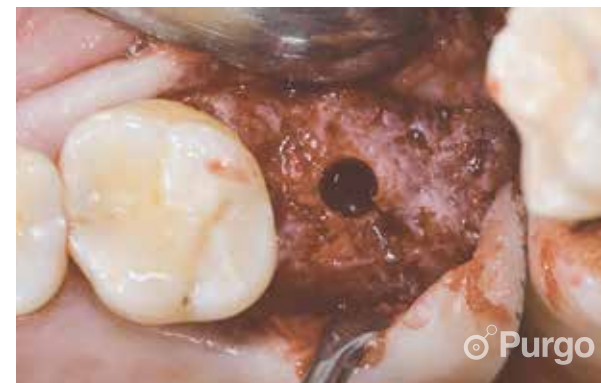
6 Samples were taken for biopsy

It is a case where GBR was performed with THE Graft and a resorbable membrane. 5 months after the extraction of #27, implant placement was attempted, but failed due to a large bone defect and the implant was placed after 20 months due to patients' personal reasons. The result of the biopsy shows increasing amount of newly formed bones as the bone substitute is being resorbed. This case shows that bone defect can be recovered through grafting the xenograft, THE Graft alone.

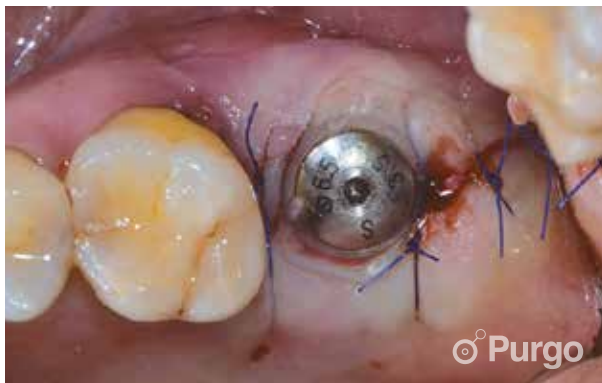
7 Placing healing abutment after checking whether there is enough bone torque for the implant placement

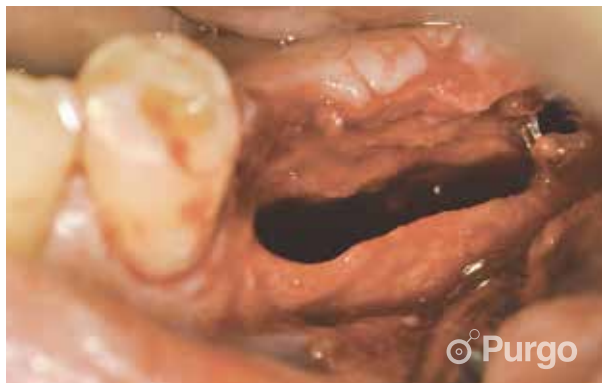
1 After removing the failed implant and inflammatory peri-implant tissues of #35, a huge amount of bone loss was occurred, but it was observed that the surrounding cortical bone was maintained (15.9.2)

It is a re-implantation case after removal of inflammatory responses around the previously placed implant at left mandibular premolar. Previous implant was placed at #35~37 on May, 2015, and after 3 months, fixture as well as inflammatory tissues were removed due to inflammatory response and patient's discomfort. Although there was large amount of bone loss, fortunately, cortical wall was still remained. Bone defect was regenerated with THE Graft and BioCover, and the case was completed with the loading of prosthesis. The result was successful clinically as shown in the biopsy, and it is well maintained until today.

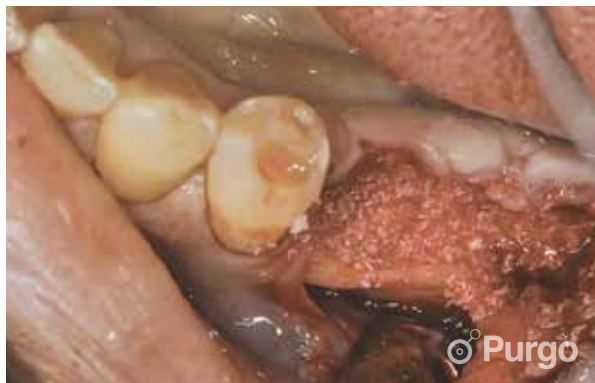
2 Grafting the bone substitute, THE Graft

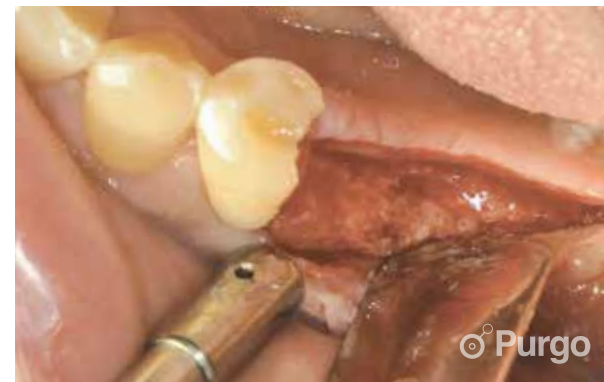
6 Re-entry for the implant placement (16.3.9)

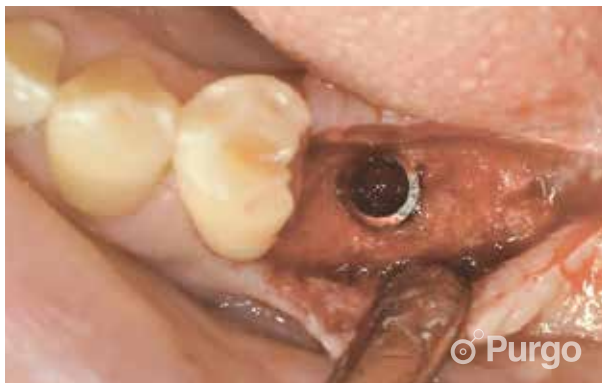
7 Re-placement of Implant for #35

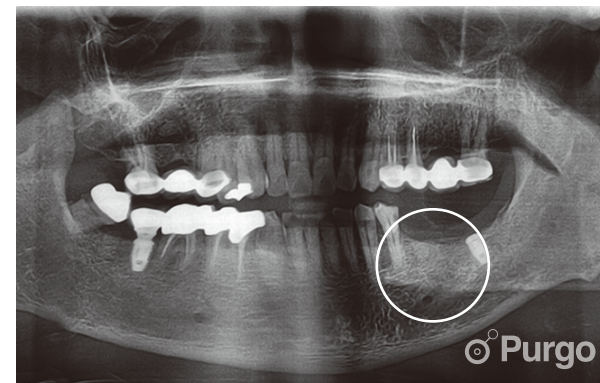
9 Panorama after removing the failed implant for #35 (15.9.2)

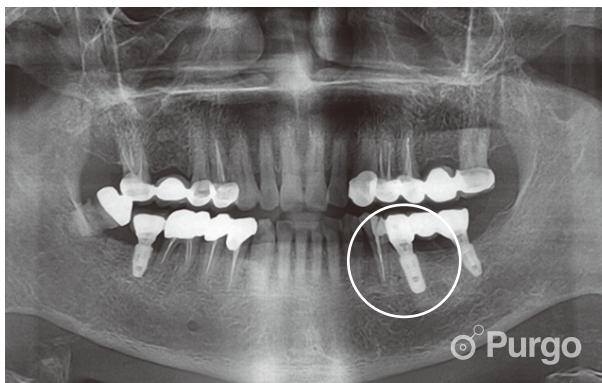
10 Panorama after loading prosthesis (16.7.20)

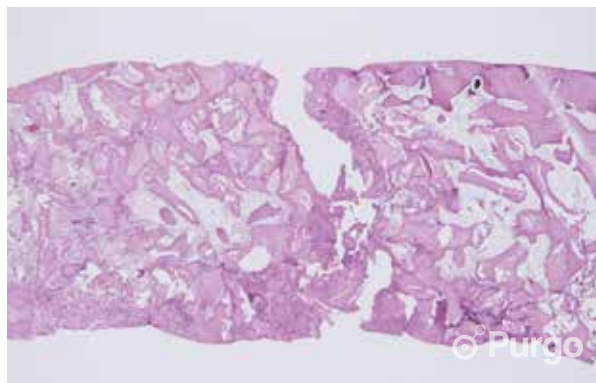
11 Excellent bony remodeling with good prognosis

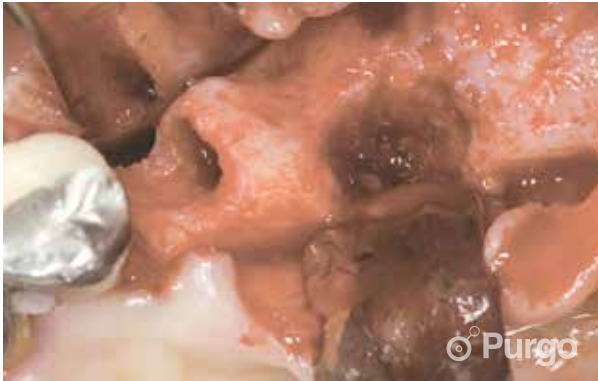
1 Flap opening after extraction of #25 ~ 26

Vertical bone defect was visible on the mesial side of #25, while vertical and horizontal bone defect and mobility was visible at #26. After extraction, immediate implant placement and bone grafting was proceeded on the mesial and buccal bone defect of #25, and also for #27, bone grafting was performed for mesial bone defect. It has been a year since GBR was performed, and a favorable process of bone regeneration is visible radiologically.

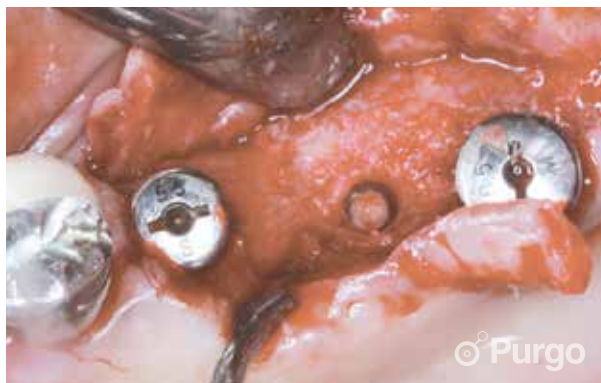
7 Samples were taken for biopsy after the placement of healing abutment

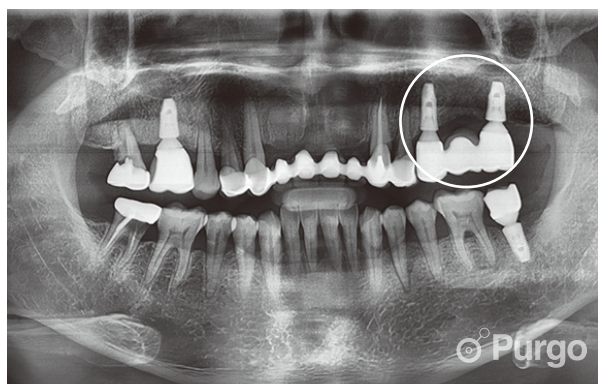
11 Panorama after loading prosthesis (16,6,14)

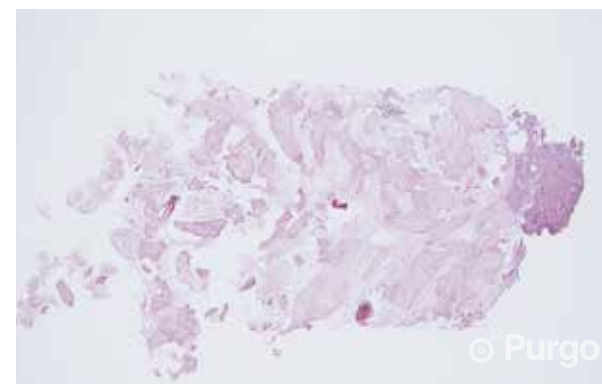
12 Partial bony remodeling

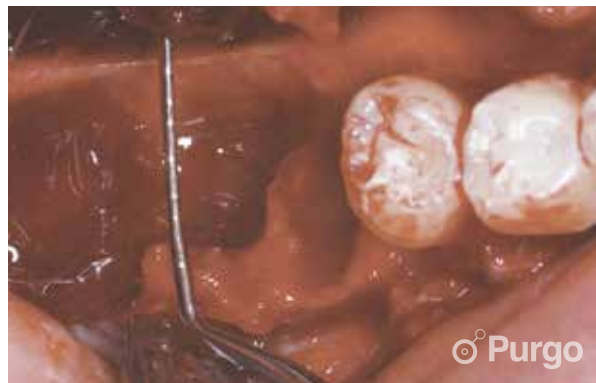
2 Extraction of #46 ~ 47, bone defect was observed after flap opening (15.7.2)

THE Graft was grafted after the extraction due to horizontal and vertical bone defect at #46 and 47.
Although the membrane was exposed, there was neither inflammatory reaction nor bone loss.
Implant was placed after 5 months, and currently a temporary tooth is placed. This is a successful case based on the histological observation.

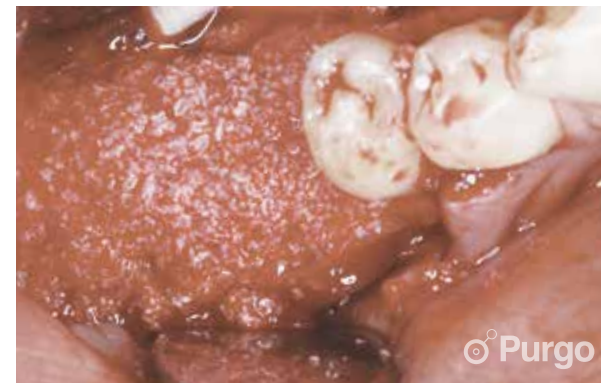
3 Grafting the bone substitute, THE Graft

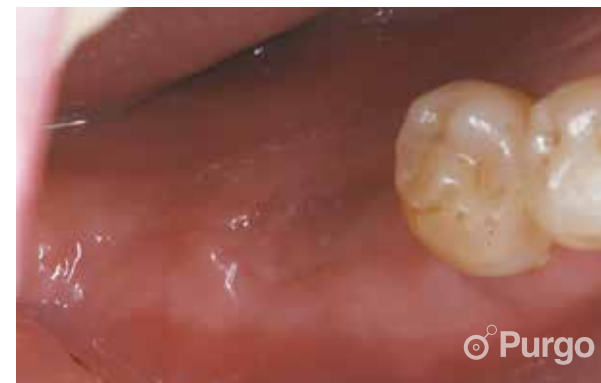
6 Healing process before re-entry (15.12.1)

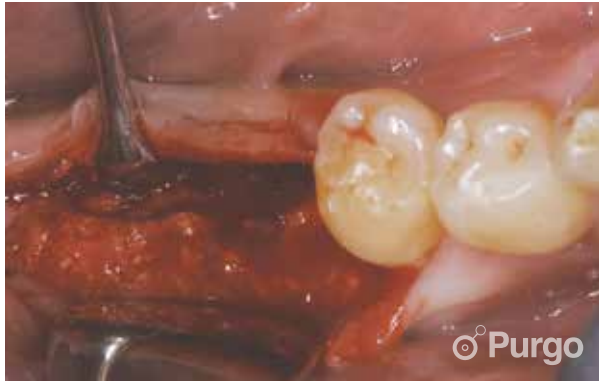
7 Re-entry(15.12.1)

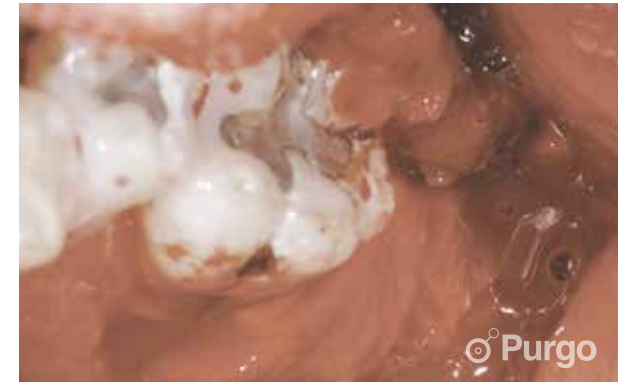
3 Grafting the bone substitute, THE Graft, and applying the resorbable membrane, Ossix Plus

The patient visited our clinic due to the discomfort and mobility of the left molar teeth #2 for extraction and implant placement. Since a severe bone resorption on the buccal and lingual side was observed, extraction and at the same time, bone grafting procedures were recommended in order to improve the remaining bone height. Prior to procedures, inflammation was minimized with administration, and the flap was reflected with keeping the lower granulation tissue in its original place at the same time. After the lower bone defect was examined, the xenograft, THE Graft was grafted and on the upper part, the cross-linked collagen membrane, OSSIX PLUS was applied and sutured with the granulation tissue. At this point, releasing incision was not conducted purposely. After suturing, a partial exposure was observed but after 7 months, a satisfactory outcome was visible clinically as well as histologically.

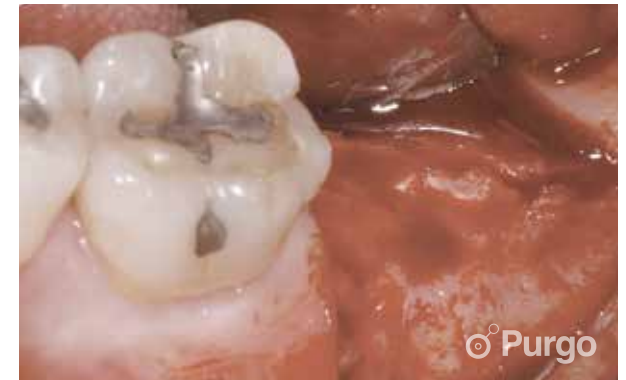
6 Re-entry, samples were taken for biopsy

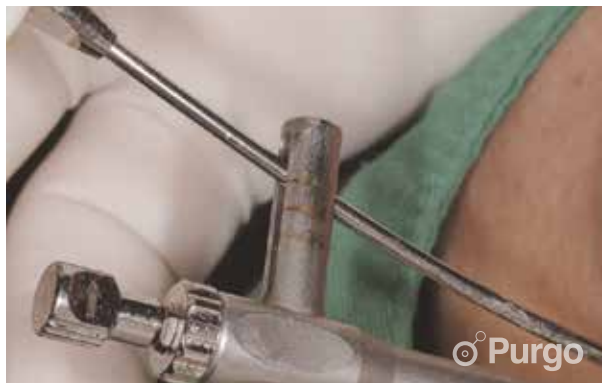
7 Confirming the enough bone torque for implant placement

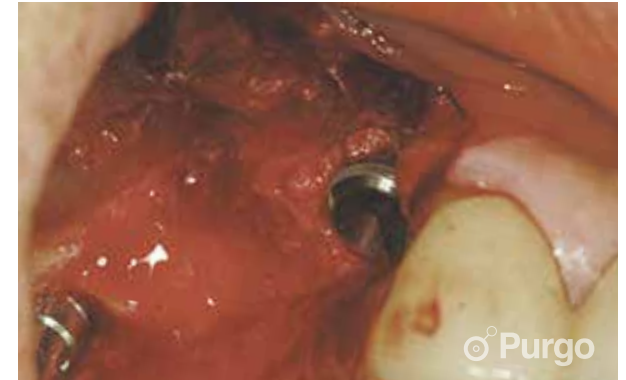
3 Buccal view

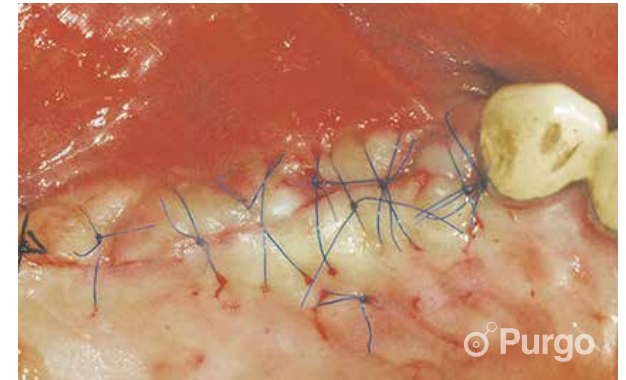
6 Suture

For a recovery of vertical bone defect, if non cross-linked resorbable membrane is applied, additional materials such as titanium mesh may be needed in order to maintain the bone frame due to the failure in keeping the bone volume. But since BioCover6 was excellent enough to maintain space with good handling property, it is recommended that it can be used alone for horizontal bone augmentation.

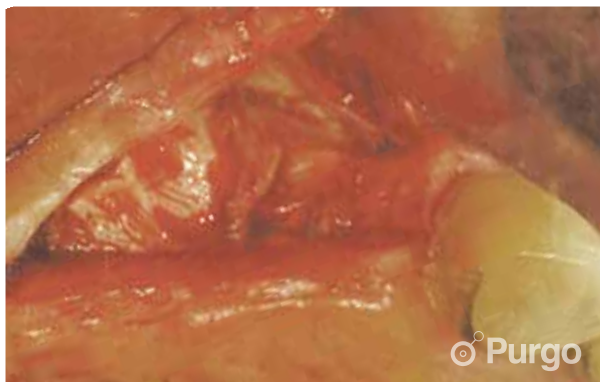
7 Re-entry, the resorbable membrane, BioCover6, is still functioning as barrier (16.3,21)

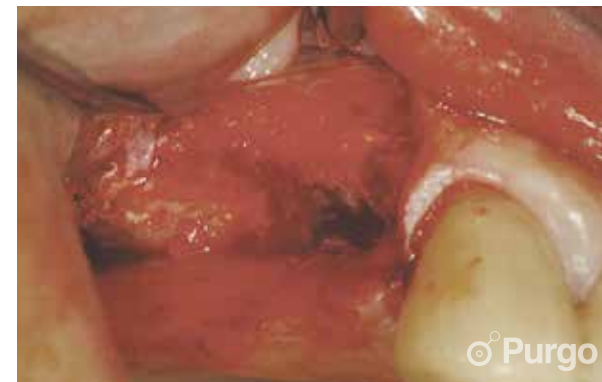
9 Healing process of the bone defect after removal of BioCover6

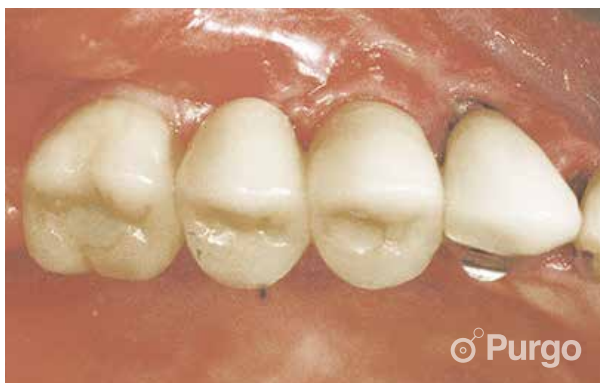
10 Prosthesis (16.6,16)

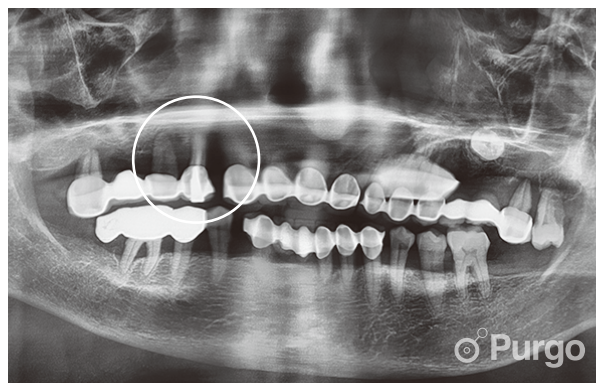
11 Pre-op panorama (15.9,15)

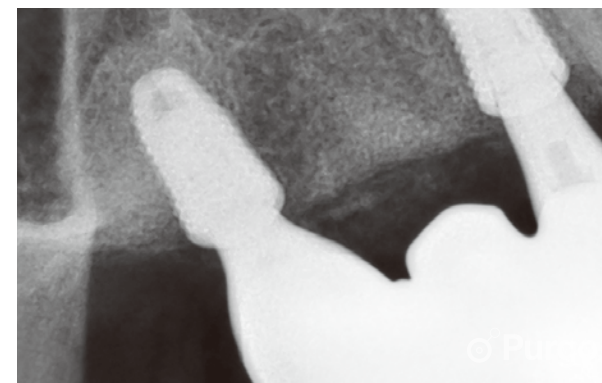
12 Radiograph of prosthesis (16.5,27)

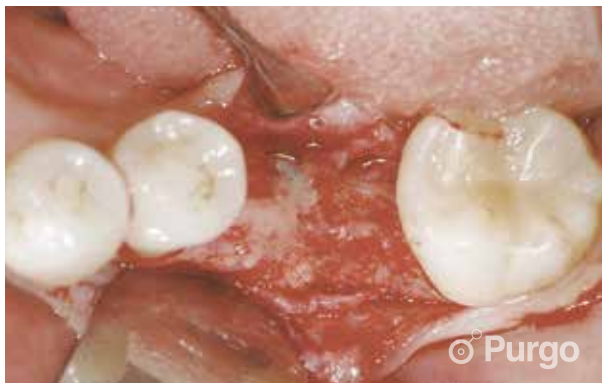
7 Re-entry for the second surgery (15.6.23)

It is a case of a patient who needed an implant for the lost, left mandibular molar #1.
 As it has been a while since the mandibular molar was lost, a severe horizontal bone resorption was observed.
 Ridge splitting was performed for stability, and the defect was transformed into contained defect, and GBR was performed with the xenograft,
 THE Graft, and the resorbable membrane, EZ-cure. After 6 months, the second surgery was conducted and the prosthesis was made. The result was clinically satisfactory.

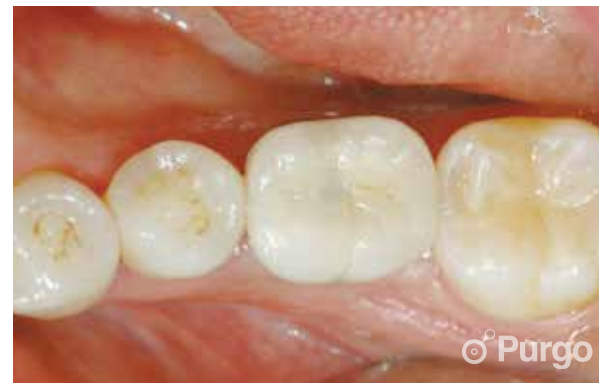
9 Checking after the prosthesis (16.1.27)

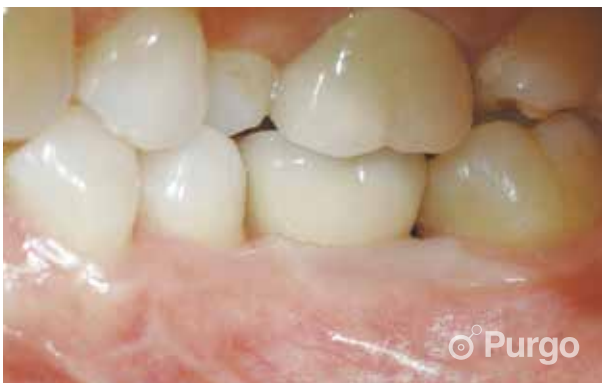
10 Buccal view after loading prosthesis

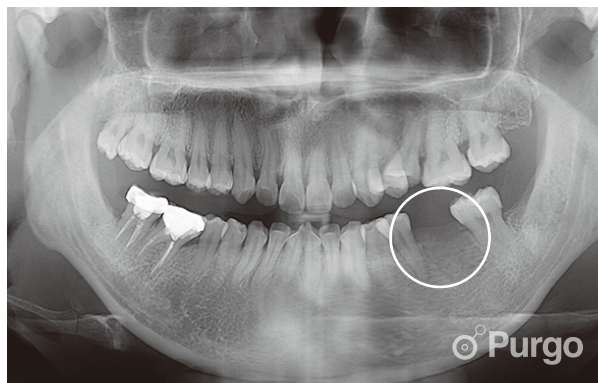
11 Pre-op panorama (14.12.17)

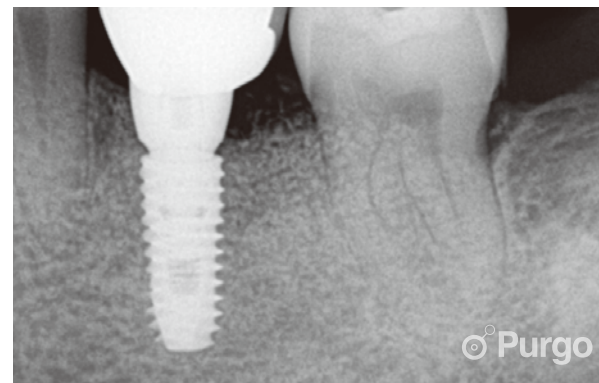
12 Radiograph after loading prosthesis (16.4.23)

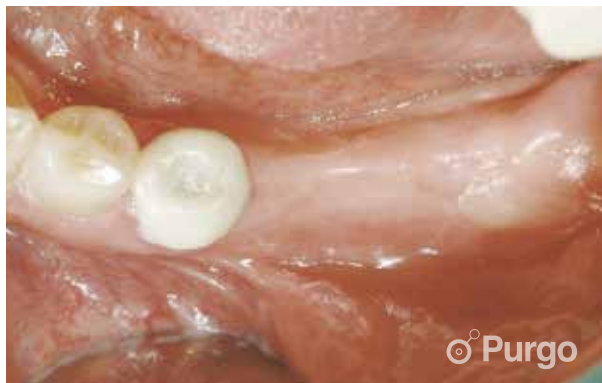
1 Pre-op clinical photograph (15.6.8)

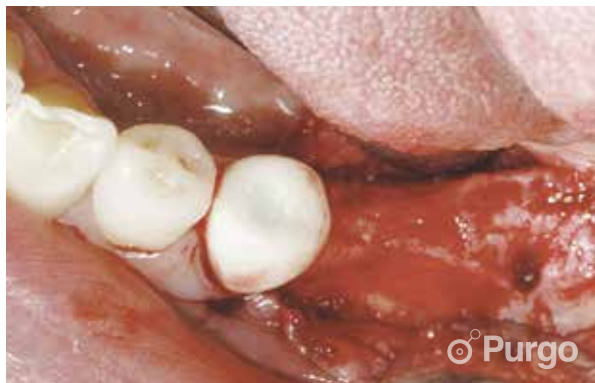
2 Flap opening, narrow alveolar ridge is observed (15.6.26)

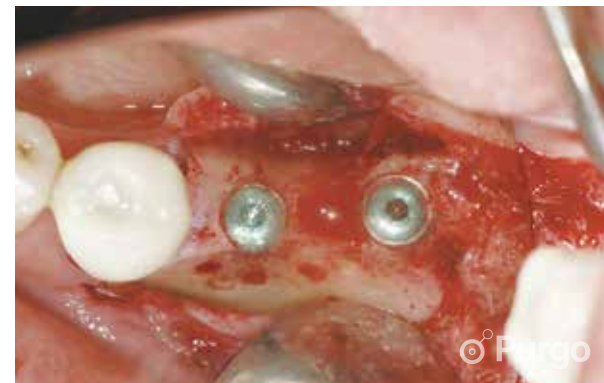
3 Implant placement

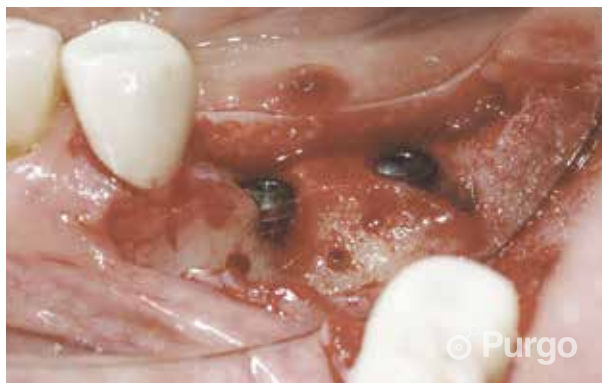
4 Decortication was performed for the buccal dehiscence defect

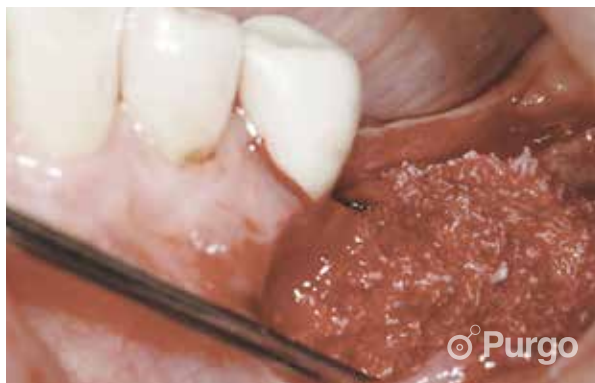
5 Grafting the allograft, ICB cancellous bone at peri-implant and xenograft, THE Graft at the surrounding area. Suture after applying the resorbable membrane, EZ-cure

It is a case with implant placement for mandibular molar where horizontal bone defect was observed. After the implant placement, an additional GBR was performed on the buccal side with allograft ICB cancellous bone, xenograft THE Graft, and the resorbable membrane, EZ-cure. After 4 months, the second surgery was conducted and prosthesis was loaded. The result was satisfactory clinically.

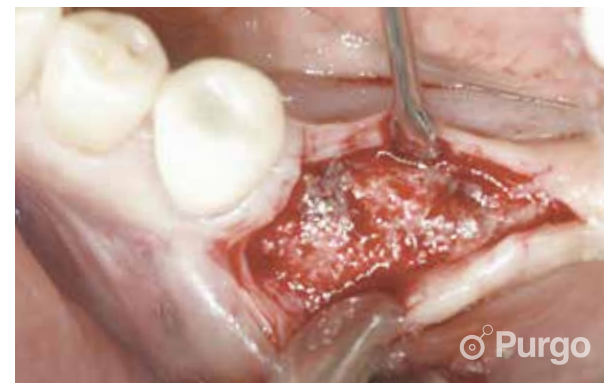
6 Re-entry for the second surgery (15.11.16)

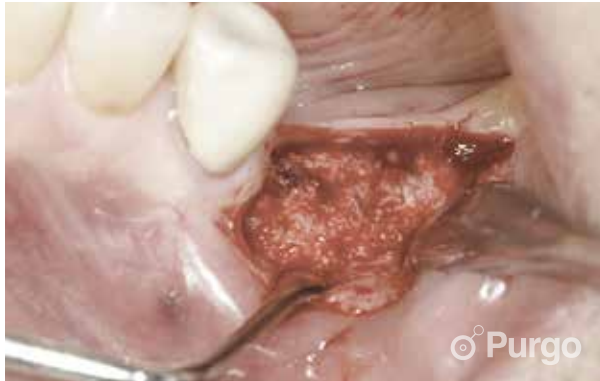
7 Buccal view

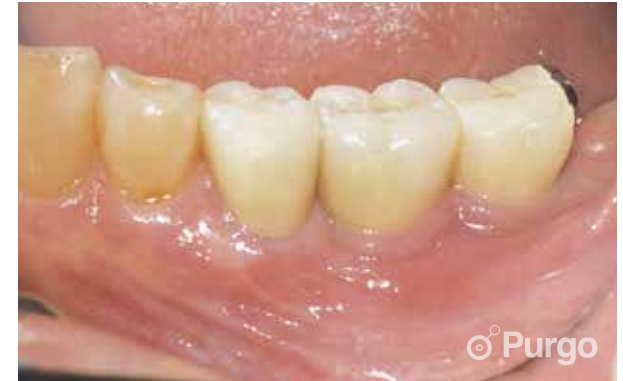
9 Buccal view of the prosthesis

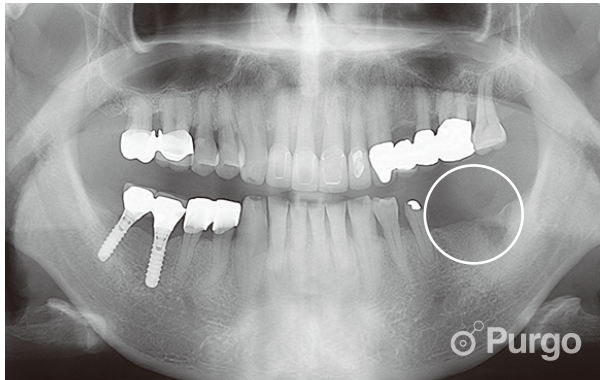
10 Pre-op panorama (15,6,8)

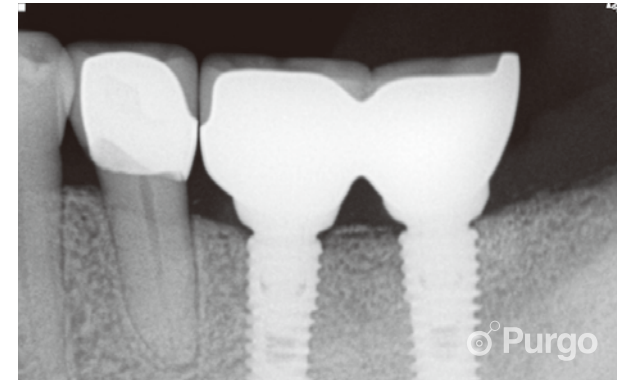
12 Radiograph after loading prosthesis (16,1,25)

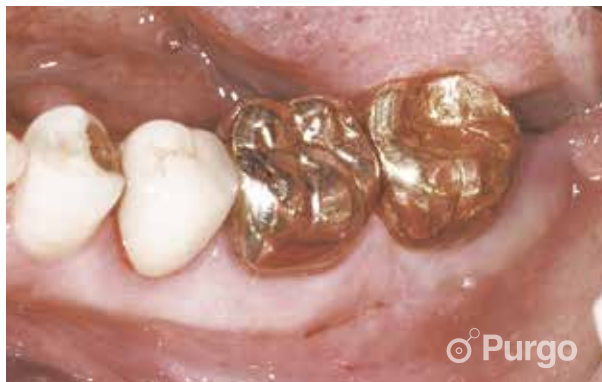
1 Pre-op clinical photograph (16.3.10)

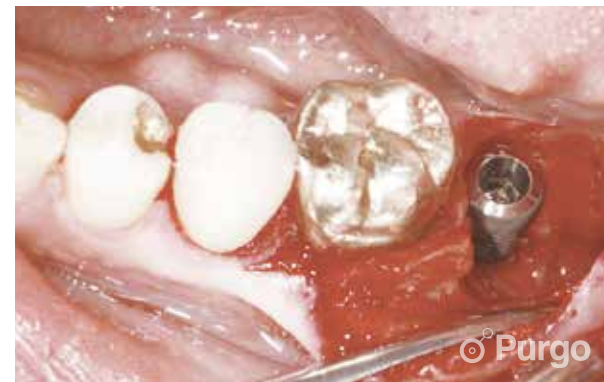
3 Healing Abutment is placed after implant placement

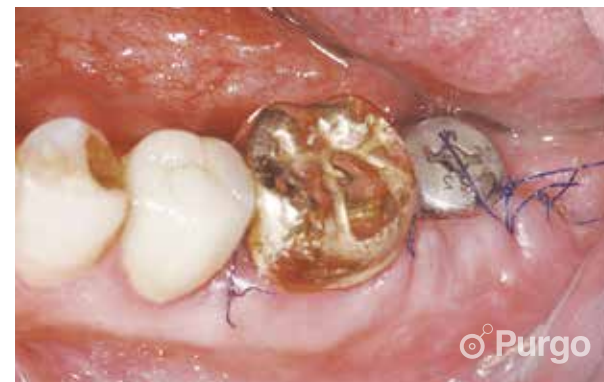
6 Healing process before removing the suture, 2 weeks after the surgery (16.3.24)

This is a case where transmucosal GBR was performed with implant placement for the self-contained defect. Although there was a large bone defect on the buccal side, a favorable result was observed when re-entry was performed. The superior osteoconductivity of THE Graft and tissue integration function of BioCover evidence that they are optimal biomaterials for transmucosal GBR when there is self-contained defect.

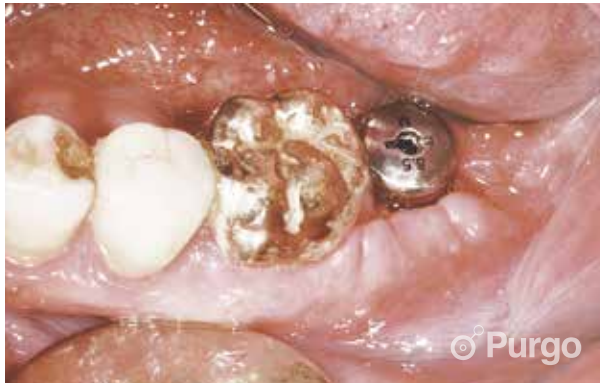
7 4 weeks after the surgery (16.7.14)

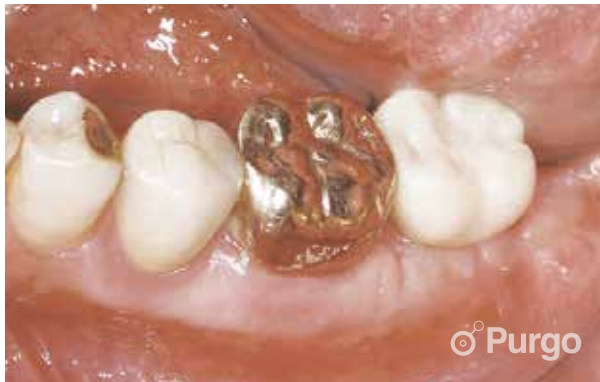
10 Prosthesis (16.8.11)
