The 2nd Clinical Case Report of "THE Graft"

THE Graft Natural Bone Substitute Cancellous Granules

'THE Graft' Clinical case Report Summary A Technology that gives a predictable clinical result to every Surgeon

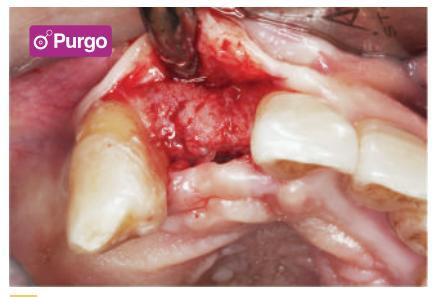
9 2nd surgery re-entry, bone formation observed after lifting the valve

G The ICB cortical bone and THE Graft used on the extraction has great volume and bony tissue maintenance **JJ**

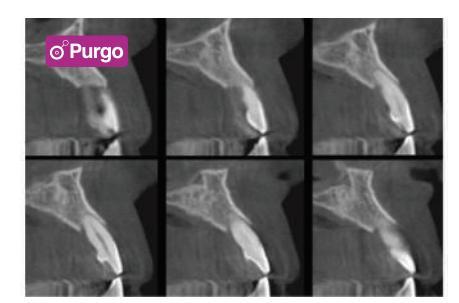
14 CT before surgery

15 CT after Surgery

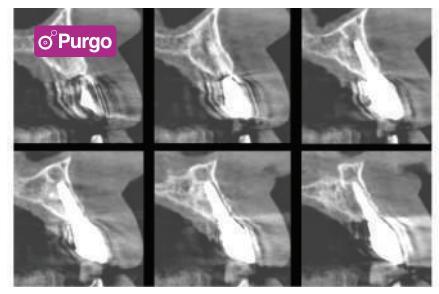
16 CT after Prosthesis

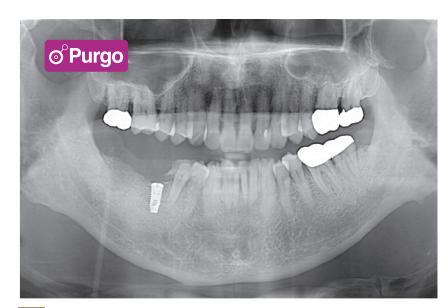
4 Panorama of Implant placement on #46, insertion of THE Graft on #47

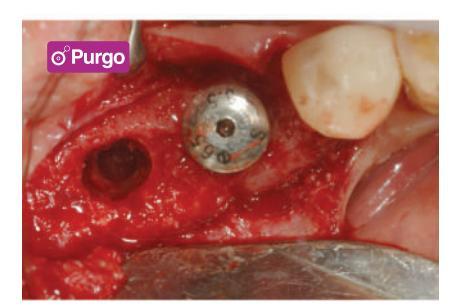
8 Collecting biopsy sample

After extraction due to severe molar vertical bone absorption on the bottom right mandible, THE graft was used for preservation surgery. The defected area was effectively recovered and great new bone regeneration was observed during histologic observation

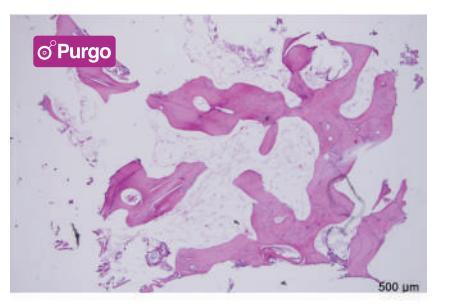
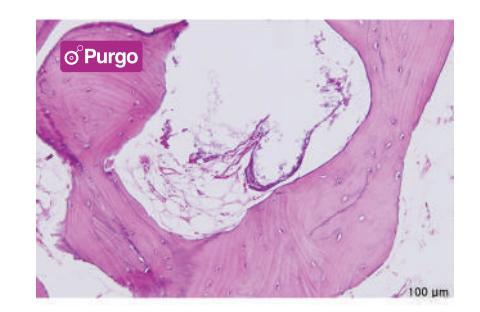
Pathologic observation of Tissue

- 1. Decalcified section showed the production of thick trabecular bone which were well anastomosed each other. These new bones were admixed with foci of small graft bones, which were almost resorbed and modified by osteoblastic new bone.
- 2. The remaining graft bones were hematoxinophilic and partly degraded into granular materials.
- 3. There appeared no inflammatory reaction and no stromal fibrosis in the marrow tissue.
- 4. The graft lesion was competent with excellent bony remodeling, producing anastomosed trabecular structure.

#47, mesial bone, THE Graft, for 4 1/4 months.

Excellent bony remodeling.

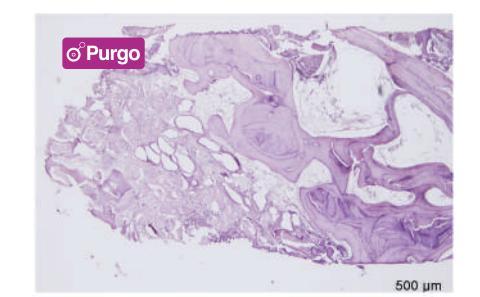
Partial bony remodeling, Kang Lung Won Ju University Dental Hospital Department of Oral Pathology Surgical Pathology Report, OS 2015–077

The buccal side was severely damaged and severe bone defect was found around the extraction. **J**J This case was cured by using THE Graft, and proper bony tissue and volume for implant insertion was formed

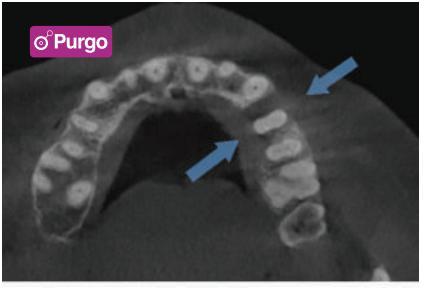
13 CT1 before surgery (13.11.19)

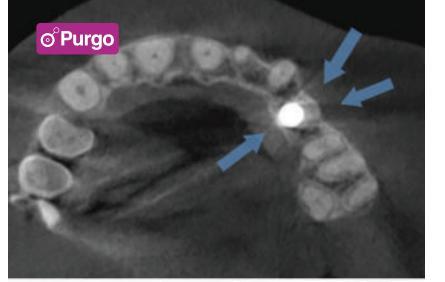
15 CT1 after prosthetic (15.8.14)

THE Graft was inserted along with the implant in the buccolingual 2 months after extraction and placed titanium mesh. Satisfactory bony tissue and volume was observed

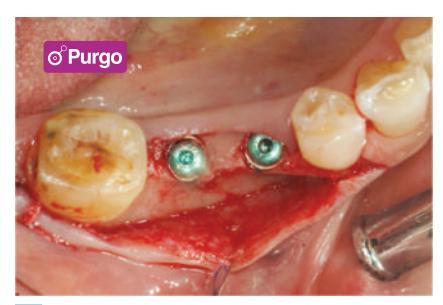
4 Observation of bone defect on the buccal side

The patient spent a considerable time in the edentulous status which made the width of alveolar ridge very narrow. THE Graft has great handling property which made it easy to buildup volume, and bone regeneration was observed on the bone defect during the 2nd surgery after 4 months

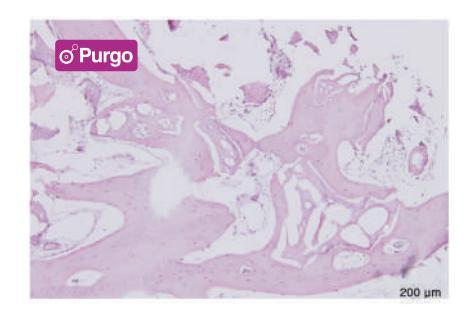
·		
Partial bony remodeling with		
good prognosis,		
Kang Lung Won Ju University Dental		
Hospital Department of Oral Pathology		
Surgical Pathology Report, OS 2015-075

The patient felt discomfort due to missing molar on the right side and according to the result of CT and tests, **JJ** there is a lack of horizontal bone elevation. Therefore, implant after bone grafting was planned for treatment. **JJ** THE Graft and BioCover were used on ridge augmentation. After 4 months the implant was inserted, and implant prosthetic is planned for treatment after 3 months

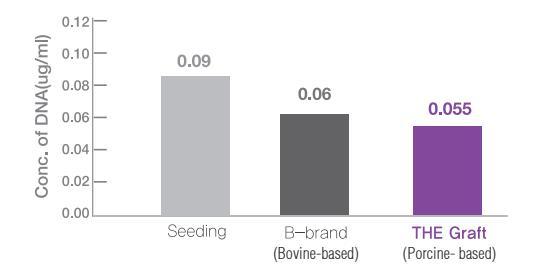
Cell Adhesion Test

It is proven through the cell adhesion test that THE graft has equally outstanding cell engraftment effect as the already existing bovine- derived graft materials.

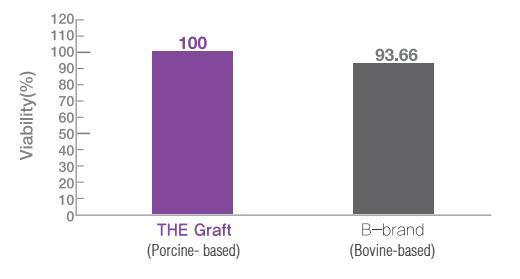
The MTT Viability Test is to measure color formation through fluorescent pigments, calculate the surviving cells and evaluate the viability of the cell. According to the absorbance density and viability evaluation, THE Graft had outstanding results compared to the other bone graft material.

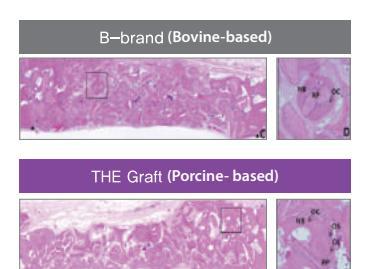
During the two and eight weeks, no unusual complications were found in both bovine based and porcine based bone graft materials. During the 2nd week, blood vessel and connective tissue, immature new bone was observed. During the 8th week a great amount of osteoblast and new bone formation around the graft material was observed. Especially during the 8th week, the porcine based graft material crated the greatest amount of new bone. Therefore, porcine based graft materials are biocompatible, and has effective new bone regenerating abilities and volume maintenance.materials.

Transversal histologic presentation of each group at 8 weeks
